Heat-treatment of Sitka spruce, Japanese larch and lodgepole pine panelling

Colin Birkinshaw, Seamus Dolan, Seamus Heaney and Eugene Hendrick

Title: Heat-treatment of Sitka spruce, Japanese larch and lodgepole pine panelling

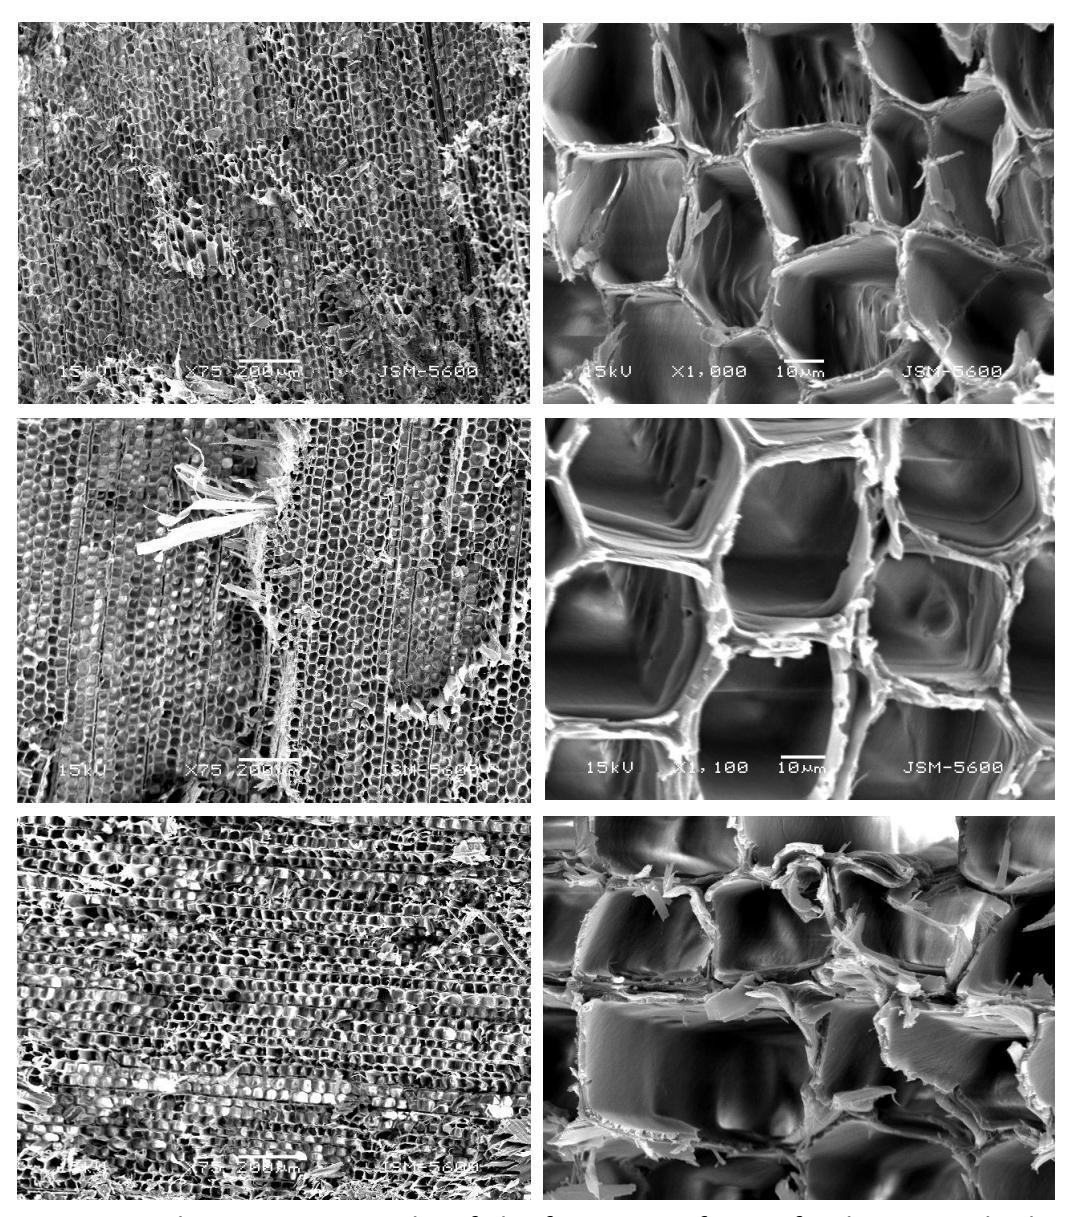
Electron micrographs of fracture surfaces, shown as Figure 4, demonstrate that in the case of control materials, cell pullout had occurred with cell walls remaining largely intact. In comparison heat-treated materials clearly show cell wall cleavage and significant delamination of the cell wall layers, particularly following the more severe treatment. The micrographs show separation of the middle lamella and it is proposed that lignin degradation within the middle lamella and within the cell wall is removing one of the essential conditions for composite material behaviour, in that stress transfer and stress distribution are seriously compromised by matrix degradation. Dynamic mechanical analysis, previously reported (Dolan, 2006) shows that there is a small change in the relationships between timber stiffness and temperature, as assessed by the temperature coefficient of modulus. Timber stiffness under small strain is substantially determined by such factors as microfibril angle (Barnett and Bonham 2004, Hofstetter et al. 2006, Yang and Evans 2004) and this will be largely unchanged by heat-treatment, whereas timber toughness under large strain is a function of the ability to transfer and distribute stress between fibrils, and this is dependent upon matrix integrity, which is damaged by heat-treatment.

Figure 4: Electron micrographs of the fracture surfaces of Sitka spruce broken in threepoint bend, from top to bottom, untreated, Platowood treatment and Lignius treatment. Failure along the middle lamellae is apparent with increasing severity of treatment.

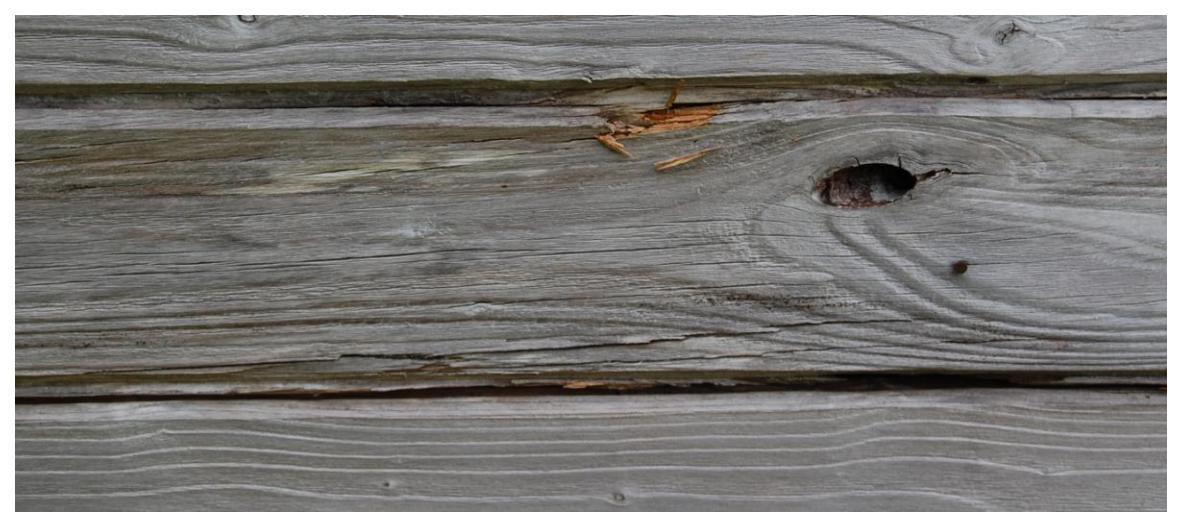
The first visible signs of fungal decay occurred in the spruce controls at 4 years of exposure, and by six years exposure decay was established in three of the controls. Decay was extensive by eight years. Figure 5 shows an example of this and as can be seen fungal attack is associated with areas where water will be retained. Some slight decay was observed in one of the cedar controls at eight years, associated with a nail hole. At eleven years no decay was observable in any of the heat-treated timbers. The three timbers used are all low durability, falling in Durability Class 5, and so this has to be considered a good result.

Figure 5: Decay in a spruce control, possibly a brown rot such as Coniophera puteana.

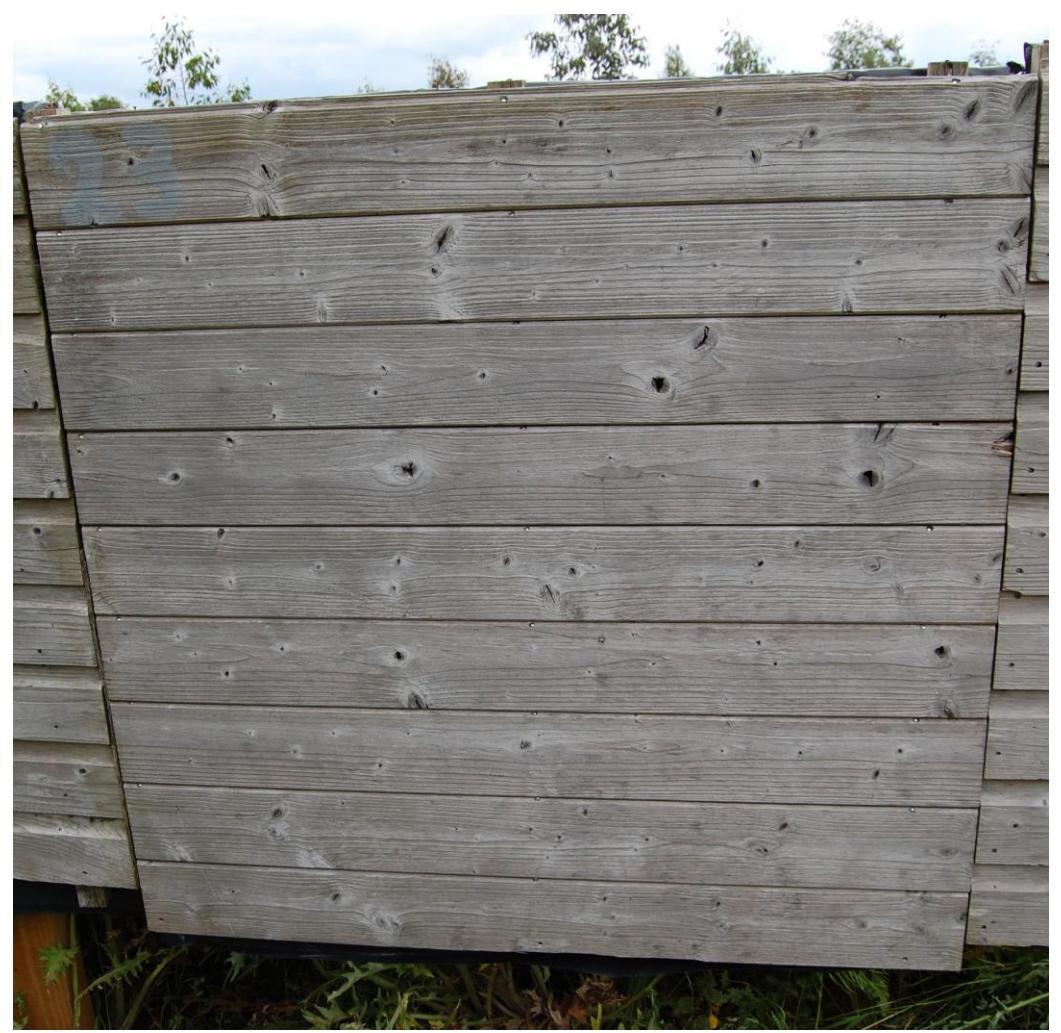
It is clear that the heat-treated timbers show a much higher level of stability than the spruce controls and are approximately similar to cedar controls. Heat-treated boards exhibit much less cup and bow and less longitudinal splits. The Thermowood treated spruce from the Wicklow Rural Partnership trial is noteworthy as showing very high stability with very few loose or lost knots and very little splitting. Panels are flat and visually the most acceptable of the heat-treated timbers. Figure 6 shows an example. Again, it must be emphasised that this appears to be selected timber. Other heat-treated materials show a relatively higher incidence of knot loss, and this was remarked upon when the wood was being machined, with knots flying away at the cutter.

Figure 6 Thermowood spruce panel after 10 years.

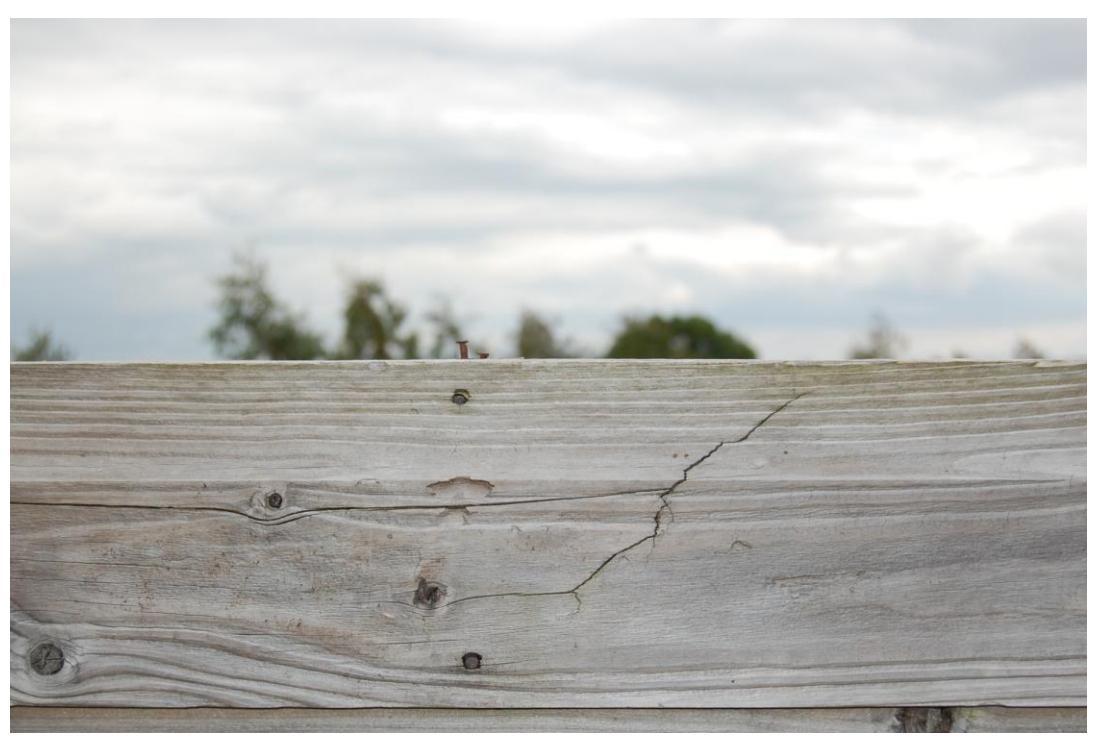
Material from the Lignius trial showed transverse cracking, as illustrated in Figure 7. The cracking and extreme embrittlement imply that the wood has been over-treated. This process used higher temperature with the wood constrained between platens and although very effective at inhibiting decay it is clearly promoting unacceptable mechanical

damage. The illustration shows a highly developed series of cracks but there were also examples of smaller cracks running perpendicular to the grain. It is considered that this represents a hydrolytically driven fatigue failure in which changes in surface moisture content and associated dimensional change promote fatigue cracks.

Figure 7: Transverse cracking in Lignius treated larch.

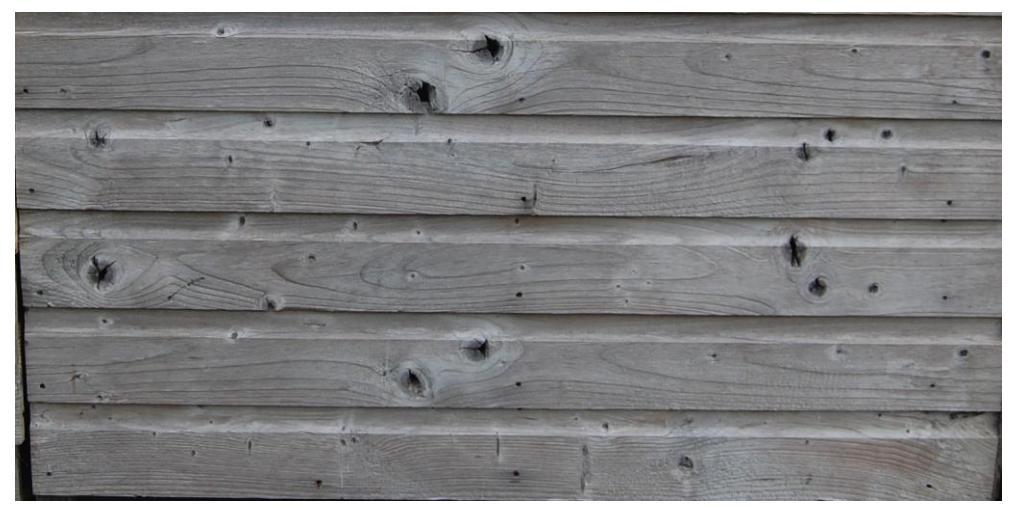
The main area in which problems were apparent with the Thermowood treated material was in some lost knots and other small defects, and many of these defects pre-date the exposure trials. Loss of knots during machining was an identified problem with all heat-treated timber, however in the Thermowood spruce the knots are small, reducing the impact of the problem. In the unselected timbers used in the other processes loss of large knots was relatively common and would result in rejection of boards and panels in an industrial situation. Figure 10 illustrates the problem and these effects arise from the hydrothermal stresses in the process and the inhomogeneity of the material. Large knots will always be a problem and similar effects have been observed with chemical modification of fast grown softwoods.

Figure 10: Example of knot damage in shiplap machined boards.

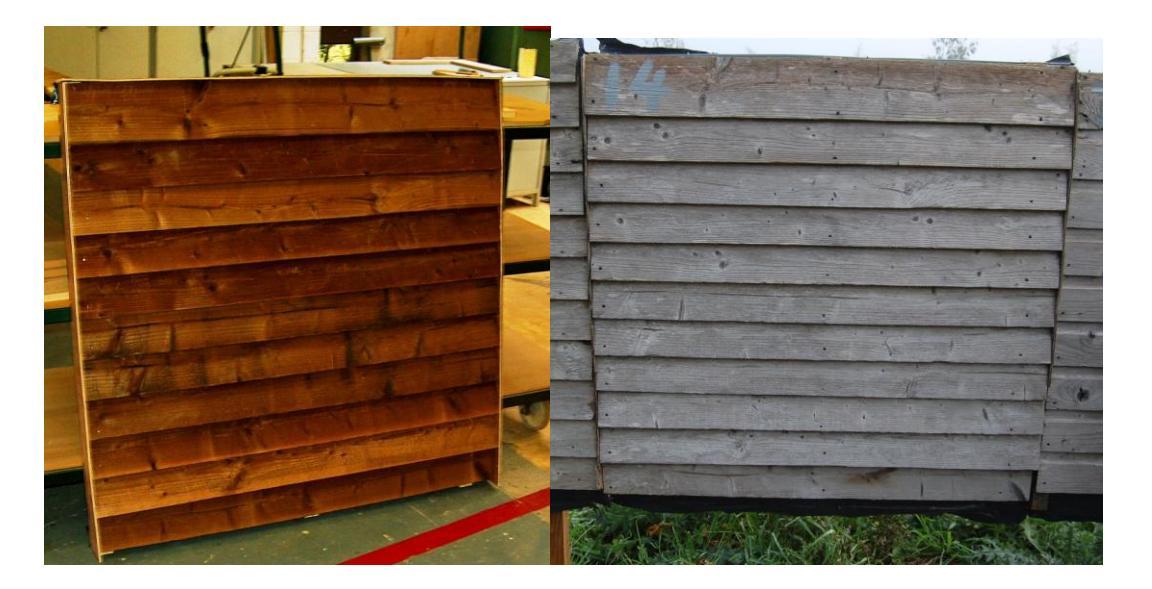
Figure 13, which shows the same sawn panel before and after six years exposure, demonstrates that this has not been observed here. Although heat-treated timbers retained their colour for slightly longer than untreated timber, ultimately all exposed material treated or not, attains the same grey colour. This suggests that although heat-treatment is effective at modifying lignin to reduce its attractiveness as fungal food source, it does not reduce the susceptibility of the lignin to photo-oxidative degradation.

Figure 13: Colour change on weathering. The left hand illustration shows a panel in the workshop, immediately after fabrication, and the right hand illustration shows the same panel after six years exposure.
